Karberg & Hennemann / CJC® Oil-Care Systems

How valuable are efficient oil maintenance and online remote monitoring for old wind turbines?

Despite serious gear and bearing failures, wind turbine #3 in the Elsterheide wind farm was able to feed electricity into the grid for another 18 months until arrangements for the gearbox replacement had been completed.

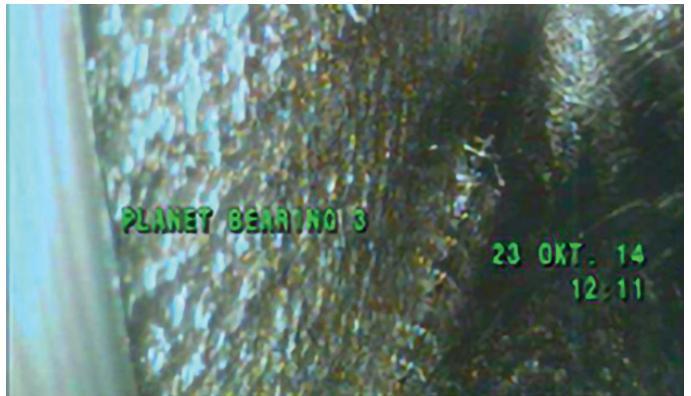
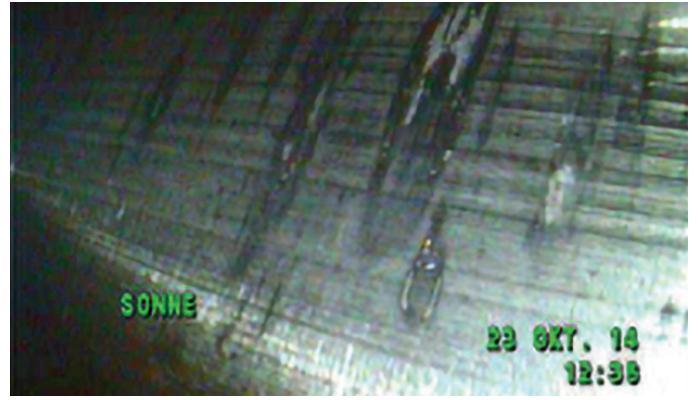
Photo, above: Endoscopy of planetary bearing: PB3 cat 5, damage width: approx. 11 mm rolling elements, Below: gearing/ttohthing: PB1-3 cat 3

In August 2014, on the basis of the biannual oil analyzes, it was detected that there had been a significant particle input. Within 6 months (February to August 2014), the cumulative content of particles $> 4 \mu$ m increased 47-fold to more than 6 million particles in 100 ml of oil. The cleanliness rating deteriorated from 17/16/13 to 23/20/13 (according to ISO 4406). The result of the inspection with borescope showed already very advanced wear with serious damage to the gearbox (damage category 5). Within a short time, it would have come to a complete gearbox and turbine failure.

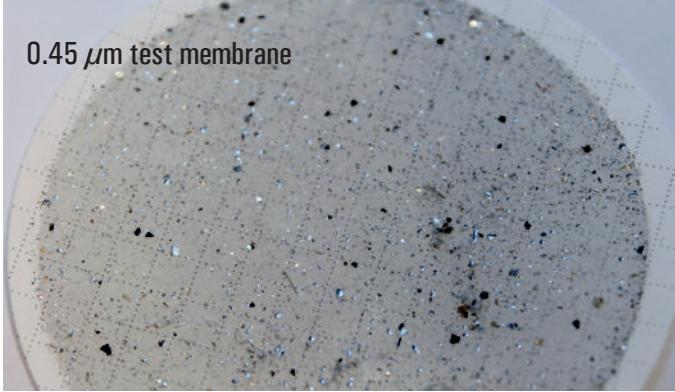
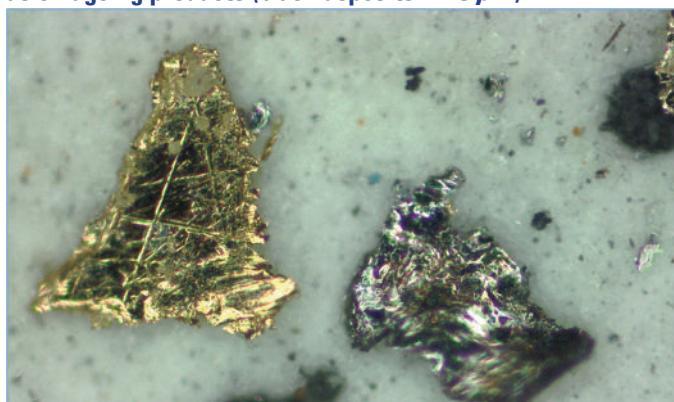
Photo, below: Enlargment of test membrane (50 times): Oil contaminated with brass, copper and iron particles from component wear (particle sizes $< 1 \mu$ m up to 2 mm) as well as oil ageing products (black deposits $< 5 \mu$ m).

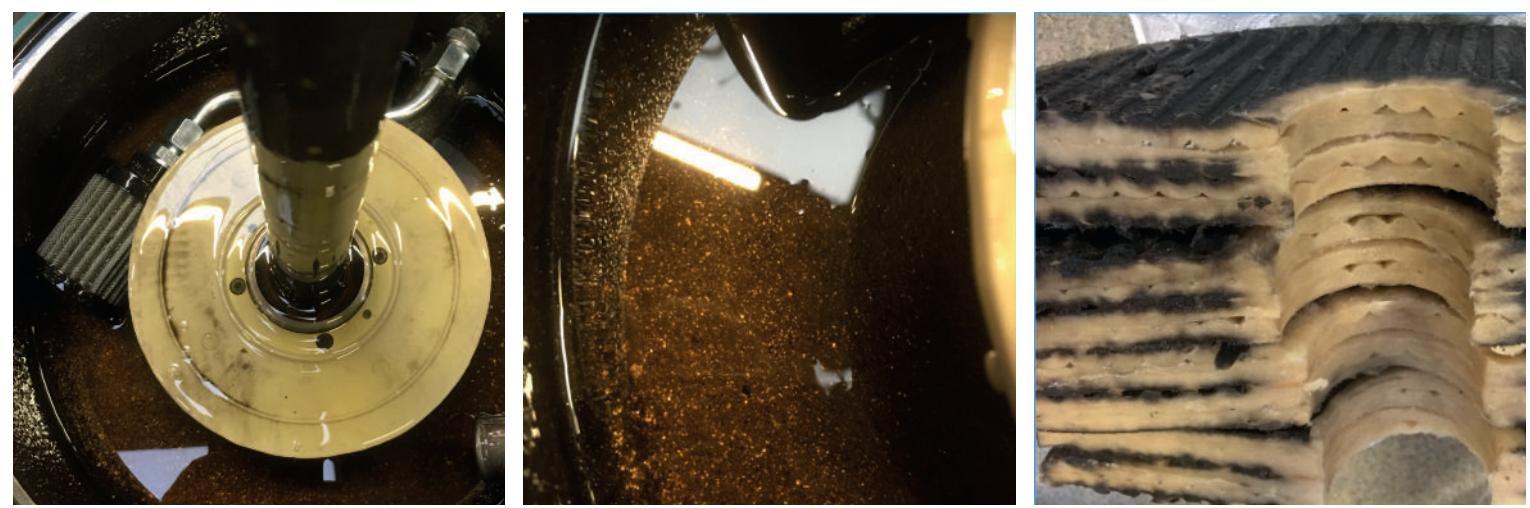
Photos, left and center: In the filter base are clearly visible the signs of the heavy oil contamination level. Metal pieces large enough to gravity settle in the relatively low filter flow document the extremely bad wear condition of the serious damaged gearbox. Photo, right: Depth filter insert after 18 months of fine filtration - still not saturated, 30-50% longer filter service time possible due to the extremely high dirt holding capacity.

To achieve this goal, two measures were taken. On the one hand, a large additional fine filter system with extensive sensor technology was installed for remote monitoring of the oil and gear condition (pump capacity: 250 I / h, filtration degree: $3 \mu \text{m}$ absolute / $1 \mu \text{m}$ nominal, depth filter, filter material: 100% renewable raw materials). The design of the filter was deliberately oversized in order to get the enormous amount of abrasive wear particles under control and to care the oil optimally. By removing particles, oil ageing products, water and acid compounds highest oil cleanliness is achieved, so that further oil-related wear is prevented. In addition, the transmission of exact oil condition values makes it possible to detect signs of abnormal wear on the gearbox at an early stage, so that intervention can be timely, cost-effective and predictable if necessary.

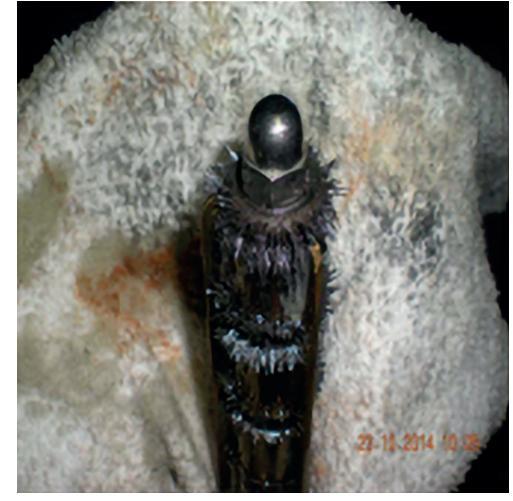
Photo, below: metal swarfs at dip stick, in the oil sump and as wipe sample.

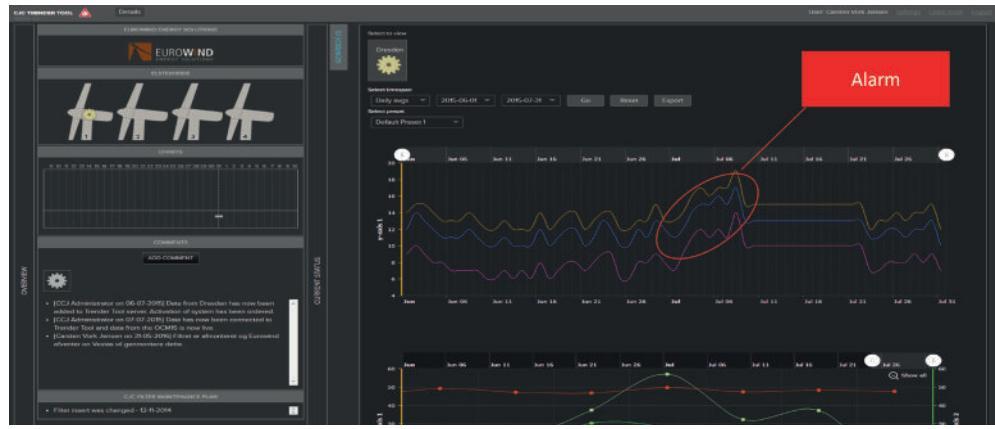
In June/July 2015 the sensor technology integrated into the fine filter, and connected to the monitoring software, T2render Tool, detected a new sudden increase in particle content and communicated an alert to the

Picture above: Data from the CJC[®] T2Render online monitoring system clearly showed the development of the particle content and the particle increase at which the alarm was sent to the wind turbine operator.

The consultation with Eurowind Energy A/S revealed that the service company had carried out a software update that unblocked the wind turbine power limit and increased the nominal power from 1.5 MW to 2 MW. The full load on the gearbox at the power limit led to accelerated wear and a sudden increase in particle content. Thanks to online remote monitoring of the oil condition using sensor technology and the early alert, Eurowind Energy A/S was able to clarify the cause and quickly take the appropriate countermeasure - regulation back to 1.5 MW - before a fatal turbine failure occurred. The wind turbine could then be in operation for another 9 months with 1.5 MW and feed electricity. The gearbox replacement was completed as scheduled on March 2016.
