CJC[™] Application Study

Ship:
 M/V "Island Scout" M/V "Island Pride"

Water in the stern tube oil in both ships.

$\textbf{CJC}^{\text{\tiny M}}$ Desorber D10 with built-in heat exchanger and pump.

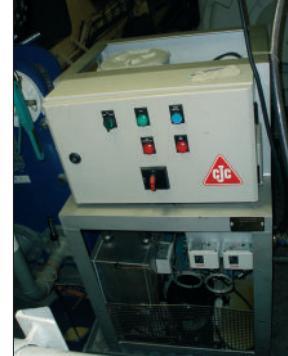
CJC™ Desorber D10

The CJC[™] Desorber circulates approx. 45 L/h and needs only 10A as the heater is only of 0.6 KW, 1 phase. The desorber proved unique for this situation as it can work while the vessel is in operation.

M/V "Island Scout" had the CJC[™] Desorber D10 on board from M/V "Island Pride" and put it into operation on the port stern tube. At that time, there was 2.4% water in the stern tube oil, corresponding to approx. 10 L of water in the system (2.4 x 400/100 = 9.6 L).

The desorber was put into operation in the afternoon on 8th of May. 15 hours later the desorber had removed approx. 5 L of water. Over the following 24 hours the desorber removed additional 5 L of water and the last oil samples showed a water content of less than 0.05%. The oil is now again clear and fine for further use on the port stern tube. Before the desorber came on board the oil had a brownish-milky colour. The Desorber D10 was moved to the starboard stern tube and with a similar result.

The CJCTM Desorber D10 was in operation for approx. 60 hours before an oil sample was taken. Over the same period, approx. 26 L of water was removed from the stern tube oil. Before the desorber was started, an oil sample showed 8% of water, corresponding to approx. (450 x 8/100) = 36 L of water in the stern tube.
